Impact of Rumble Strips on Longitudinal Joint Pavement Performance

Katie DeCarlo (kdecarlo@hrglab.com), Todd Thomas, Jason Wielinski
The Heritage Group

1 **Impact of Rumble Strips on Longitudinal Joint Pavement Performance**

1 **ABSTRACT**

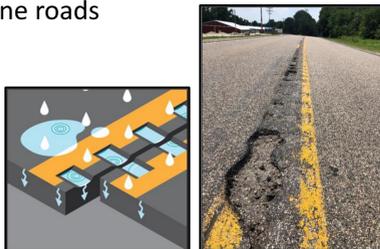
- Rumble strips are an effective and low-cost solution to reduce severe roadway departure crashes.
- NCHRP Synthesis 490: Adding centerline rumble strips resulted in:
 - 45% reduction in crashes on rural two-lane roads
 - 64% reduction on urban two-lane roads
- Challenging Questions:
 - Impact on pavement life?
 - Durability of joint?
- VRAM = Void Reducing Asphalt Membrane

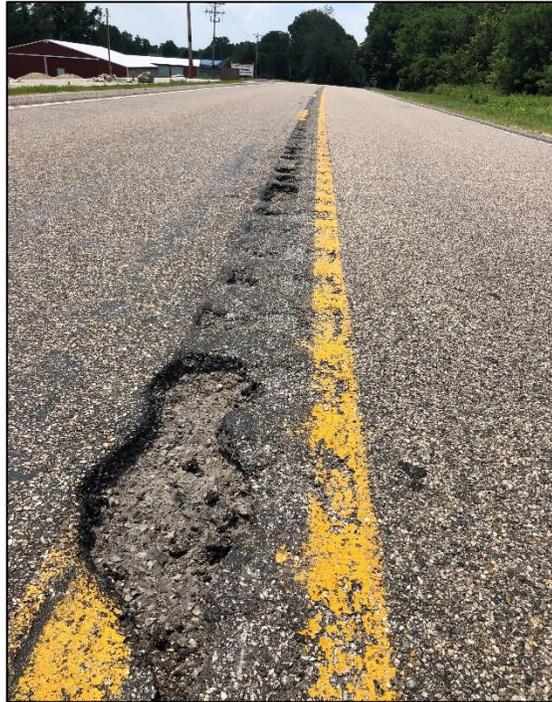
4
5 Figure 1: Example of deteriorated centerline joint with rumble strips taken on July 7th, 2021.

1 Figure 1 provides an example of a deteriorated centerline joint with rumble strips along US-36 between
2 Raccoon Lake and US-231, a highway in Indiana.
3

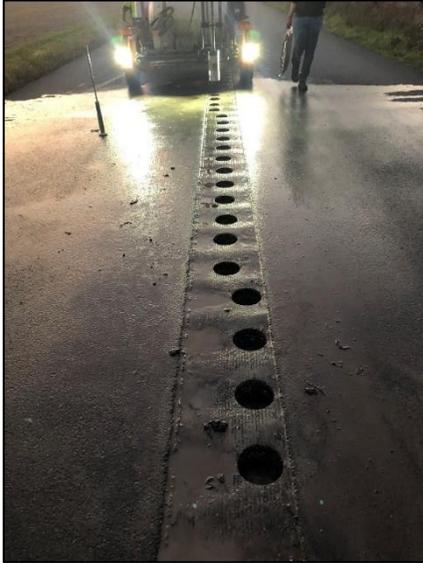
Figure 4: Example of coring along Lowell test section.

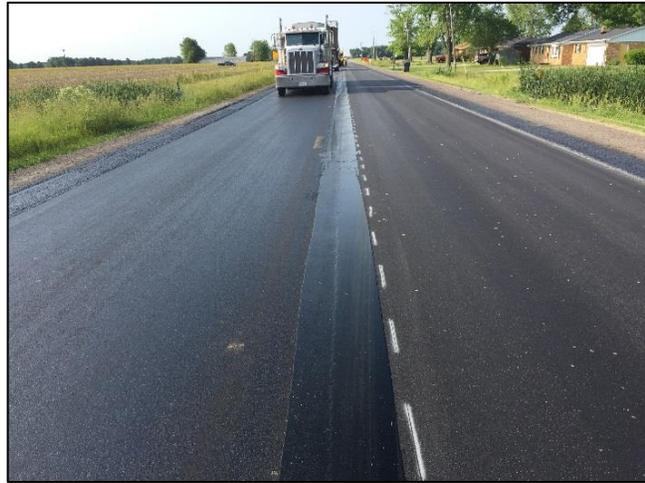
Figure 5: Application of tack coat material following VRAM along Illinois SR-1.

9 The second location included in this study was a 7.2-mile project going north from the Clark
 10 County/Edgar county line in Illinois along SR-1. Construction consisted of 2.25-inch removal of HMA, 84
 11 lb./sq-yd fine graded level binder with 1.5-inch 9.5 mm surface course. VRAM was applied on top of the
 12 new level binder mix at the centerline joint at a width of 18-inches and an average yield of 1.38 lb/ft
 13 application rate, followed by a conventional non-tracking tack coat material (Figure 5). Rumble strips were
 14 installed 8-inches wide and about 6-inches apart (front to back). This field section provided researchers
 15 with a second trial location to evaluate the bottom-up approach of mitigating potential impacts of rumble
 16 strips on joint performance on state route with approximate average daily traffic of 4,600 vehicles per day
 17 and truck percentage of 17%.

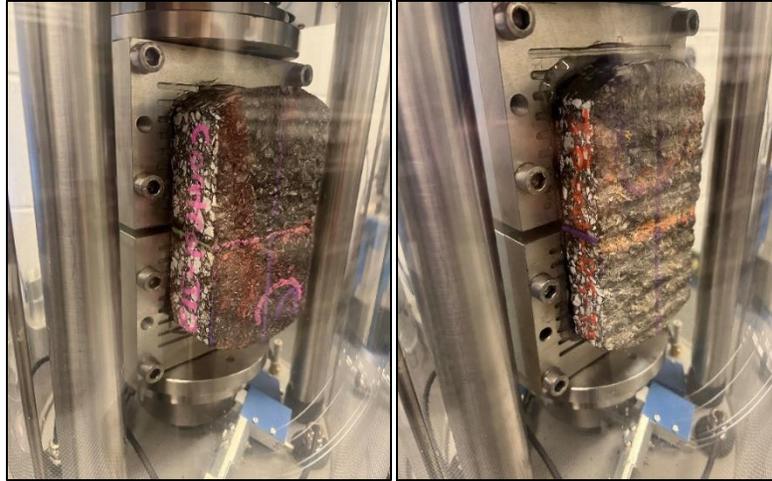
1
2 Figure 9: OT set up showing sample orientation without rumble strips (left) and with rumble strips (right).

11 *Overlay Tester (OT)*: The OT is used to assess the susceptibility of an asphalt mixture to fatigue or reflective
12 cracking. Specimen geometry can be fabricated from a 150 mm (6-in) diameter core, where the specimen
13 length is 150 mm (6-in) with rounded edges, width is 76 mm (3-in) and height equal to 38 mm (1.5-in). The
14 test is typically run at a test temperature of 25°C (77°F). The specimen is glued to two blocks: one is fixed
15 while the other is allowed to slide horizontally. Careful attention was made to cut the sample directly below
16 the VRAM system to ensure it is fully intact. OT samples were glued to the platens in such a way that the
17 bottom cut surface of the pavement is touching the testing platen and the joint was centered between platens
18 (Figure 9). The sliding block applies tension in a cyclic triangular waveform to a constant maximum
19 displacement of 0.6 mm (0.025-in). The sliding block reaches the maximum displacement and then returns

20 to its initial position in ten seconds (one cycle). Examples of outcomes that may be analyzed from this test
21 include peak load, critical fracture energy (CFE) at the maximum peak load on first cycle, crack propagation
22 rate (CPR), and number of cycles to failure. In this study, CPR results are used to compare cracking
23 resistance through the propagation phase of cores with a joint and with the introduction of rumble strips.
24

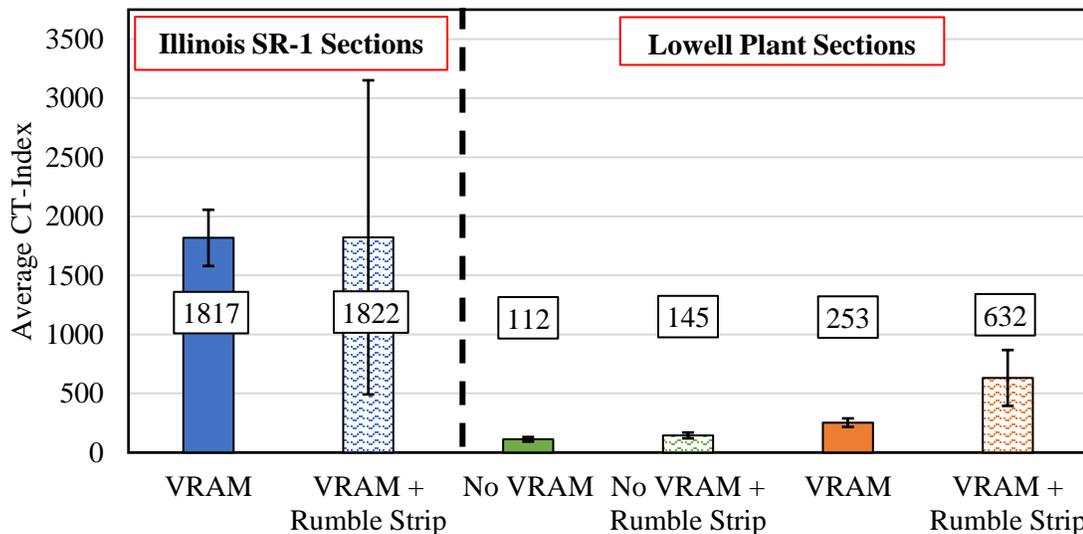
22 Figure 11: CT-Index results on field cores from centerline joint cores only along Illinois SR-1 and Lowell
 23 Plant sections. Error bars denote one standard.
 24

1 IDEAL-CT testing was also conducted on field cores from both project locations. For comparison
 2 purposes of the impact of VRAM and rumble strips on centerline joint performance, only cores sampled
 3 from the centerline of Illinois SR-1 are included in Figure 11. However, researchers noted in general lower
 4 CT-Index values for edge line cores (did not contain VRAM) regardless of whether or not rumble strips
 5 were present. In the case of Illinois SR-1, CT-Index values were significantly higher for the given surface
 6 course mixture compared to those results obtained from Lowell Plant sections. There was no significant
 7 difference observed in CT-Index with or without rumble strips for Illinois SR-1 that contained VRAM. In
 8 the case of the Lowell Plant sections, when adding VRAM, the CT-Index increases (No VRAM vs VRAM
 9 bars). However, with the addition of rumble strips, the CT-Index also increased. Researchers hypothesize

10 that there are two confounding effects taking place. First, field cores that contained rumble strips were
 11 approximately 20% thinner than those without rumble strips. Furthermore, after trimming the field cores to
 12 remove the binder layer mixture, test specimens were less than 62 mm thick, and the thickness correction
 13 factor was used. Second, since these are field cores and not lab prepared specimens, there is less control
 14 over air voids. Using the back-calculated method described above for air voids, while accounting for the
 15 added asphalt content from VRAM, it was observed in general that air voids on cut specimens were higher
 16 in Lowell Plant sections without VRAM, and higher for cores that contained rumble strips (Figure 12).
 17 Many researchers have shown that CT-Index is sensitive to air voids and as they increase, CT-Index also
 18 increases [11]. Therefore, the combination of having thinner samples and higher air voids for test specimens

19 that contain rumble strips beyond the limits of specimens used to develop the cracking index may contribute
 20 to the results observed between rumble strips and no rumble strips. Furthermore, the higher asphalt content
 21 from VRAM may be contributing to the relatively high CT-Index values for Illinois SR-1 sections.
