# Use of J-Band to Improve the Performance of the HMA Longitudinal Joint

**R. Christopher Williams, Principal Investigator**  
Asphalt Materials and Pavement Program  
Institute for Transportation at Iowa State University

Research Project  
Final Report 2020-33

# USE OF J-BAND TO IMPROVE THE PERFORMANCE OF THE HMA LONGITUDINAL JOINT

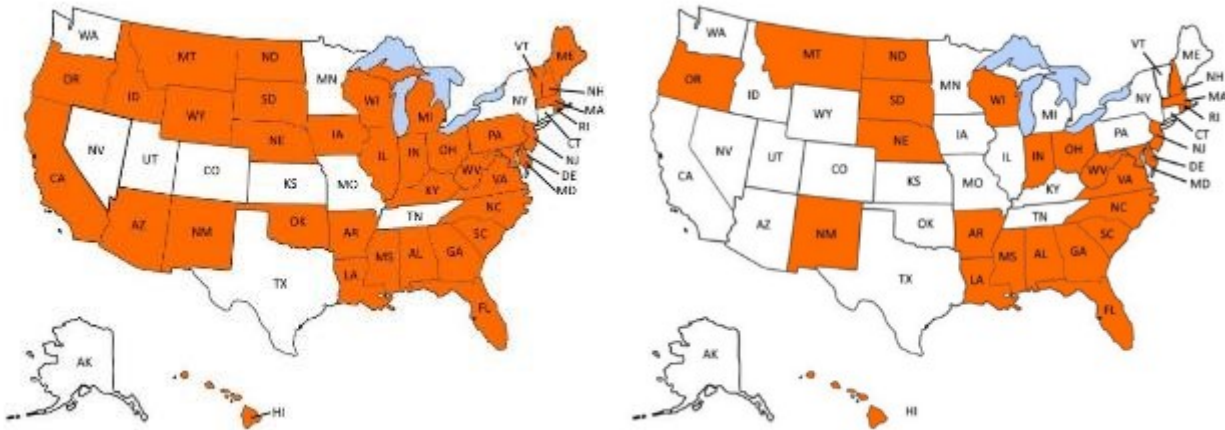
**Figure 1. State DOTs without longitudinal joint density specifications (highlighted in orange) in 2011 (left) and 2018 (right)**

Historically, the main longitudinal joint construction techniques used in the United States include the use of echelon/tandem paving, various rolling patterns, various joint types (butt, tapered, and notched wedge), edge restraining or precompaction devices, infrared joint heaters, cutting wheels, joint adhesives, and joint sealers. Researchers at Purdue University indicated that in 2011 only 12 state DOTs (those not highlighted in orange in Figure 1, left) in the United States had specifications that included a longitudinal joint density requirement. This is shown in Figure 1 (left).

By 2018, this number had increased to 24, as shown by the states not highlighted in orange in Figure 1 (right).

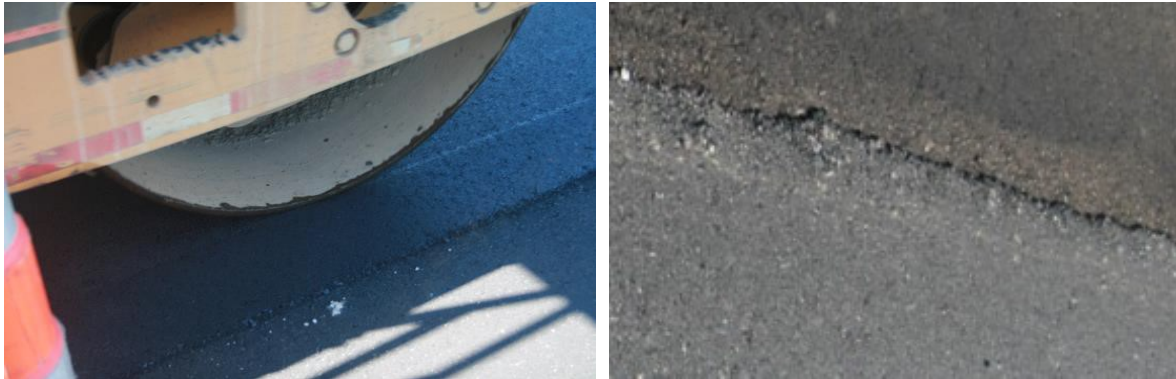
One way to correct for this issue is through pinching. In 2002, researchers from the National Center for Asphalt Technology (NCAT) in Auburn, Alabama, reported on how the modified butt joint with pinching increases the density at the longitudinal joint. Higher density was achieved by rolling from the hot lane (6 in.) away from the joint during the first pass so better confinement could be provided to the butt joint. Thus, material would be pushed between the roller and joint towards the joint during the initial

roller pass, causing pinching to occur and thereby producing a higher density at the butt joint area, as shown in Figure 3 (Kandhal et al. 2002).

**Figure 3. Butt joint construction with hot pinch on US 61**

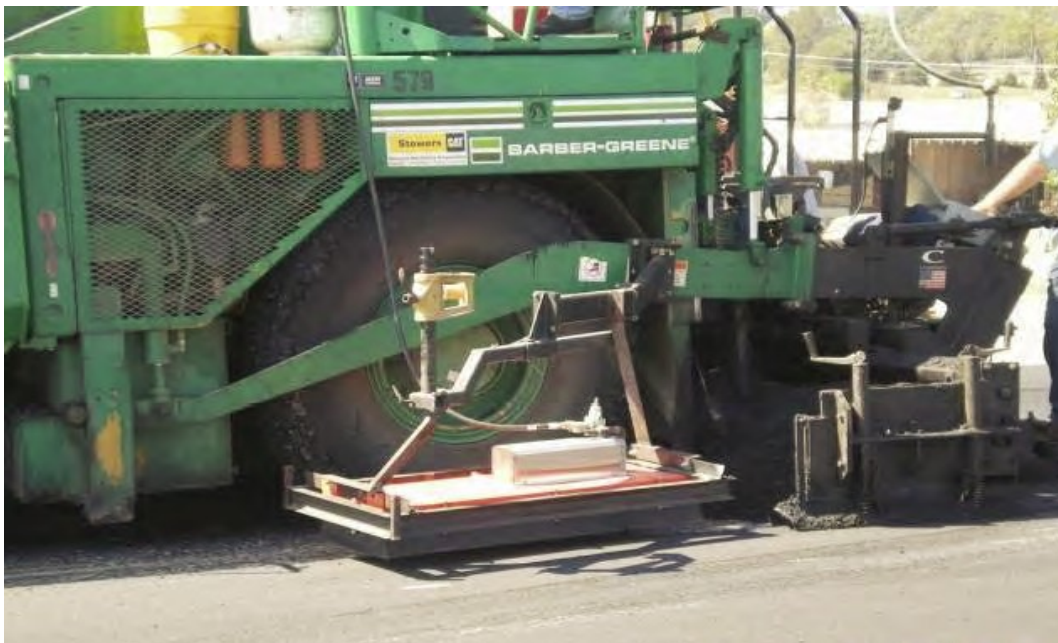
Temperature plays an important role in longitudinal joint construction. Higher temperatures are believed to be better because compaction and bonding of the cold to hot mats can be improved at the joint. This is the basis of joint heat treatment, shown in Figure 4, in which the joint area is heated after placement of the cold lane or just prior to placement of the hot lane, which makes the asphalt binder in the cold lane more viscous and stickier.

**Figure 4. Infrared joint heaters**

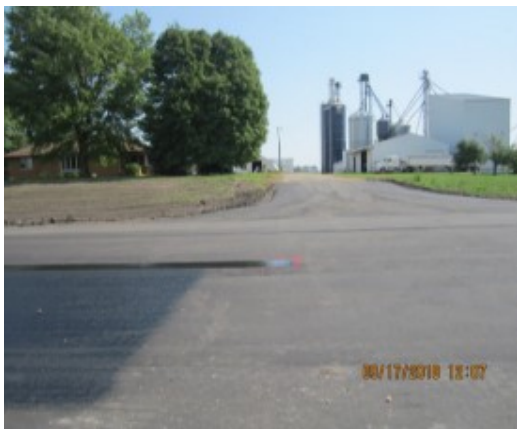
Figure 11. Start of J-Band section at farm driveway

Control and J-Band sections, each 1 mile long, were paved in 2018 between CSAH 10 and CSAH 15 on TH 22 (SP 0704-100) north of Beauford. The J-Band section started at the driveway for Knewtson Soy Products LLP (latitude 44.0480, longitude -93.9577), shown in Figure 11, and ended just north of Decoria Cemetery (latitude 44.0614, longitude -93.9589) on the west side of TH 22.

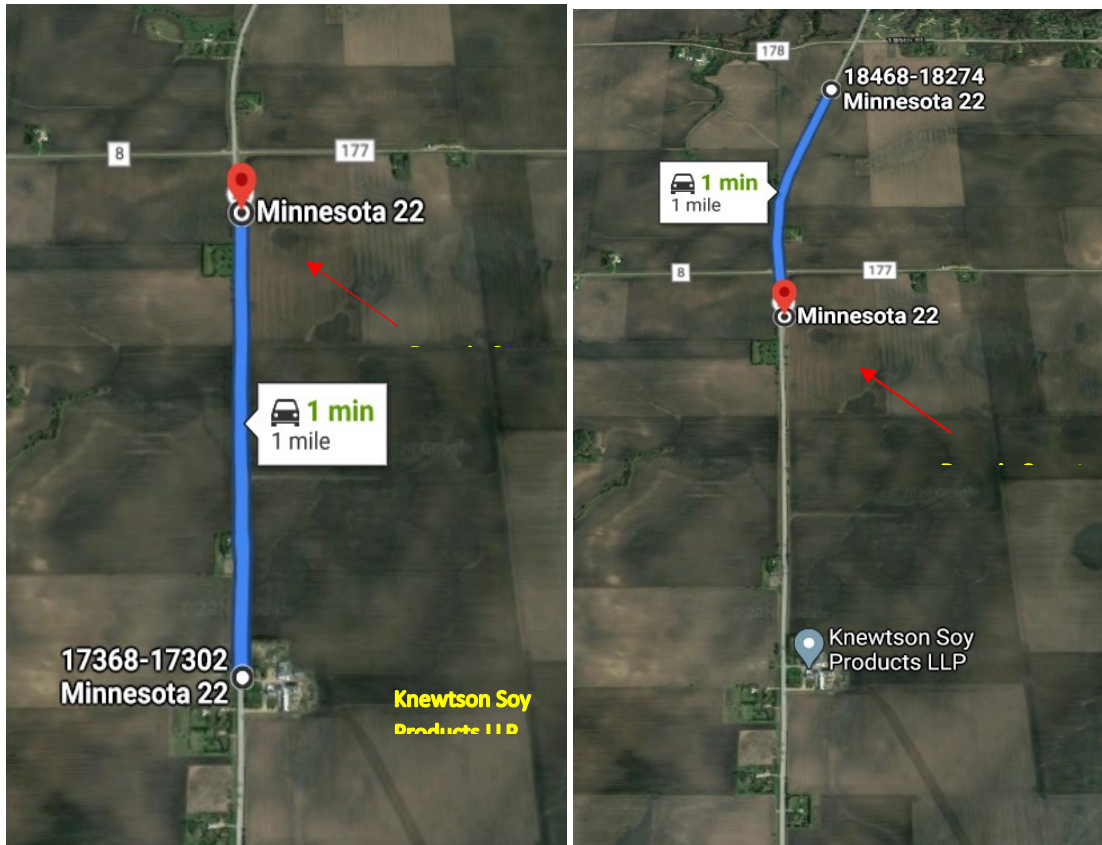
**Figure 12. J-Band section (left) and control section (right)**

The control section started just north of Decoria Cemetery (latitude 44.0614, longitude -93.9589) and ended 1 mile farther north along TH 22 at latitude 44.0762, longitude -93.9559. The J-Band and Control sections are shown in Figure 12.

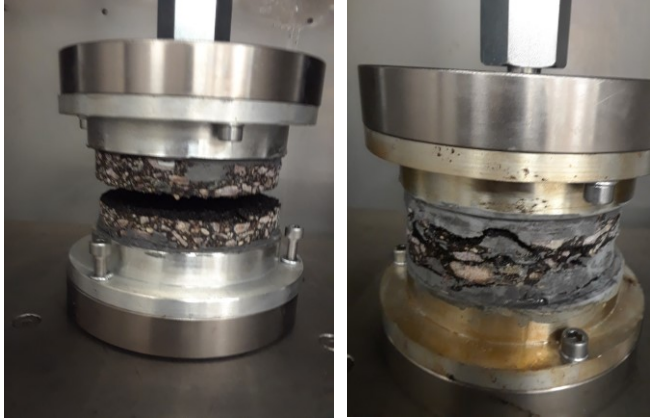
Two test methods were used to measure bond energy, one for the surface and one for the joint. The method used for measuring bond energy at the surface is similar to the viscoelastic continuum damage (VECD) approach, except that instead of testing in push-pull mode with a uniaxial-sized (4 in. diameter by 6 in. height) specimen, the specimen was put through direct tension mode at a constant rate of 0.5 mm/min. The procedure for performing this test is outlined below:

- Take a minimum of six 4 in. cores from the VRAM section and six 4 in. cores from the control section at the longitudinal joint. The cores should be taken from the centerline of the lane for the VRAM sections and next to the longitudinal joint centerline for the control sections.
- Freeze the cores and scrape the smeared VRAM from the outside of the cores.
- Cut the cores ½ in. below the interface of the VRAM or tack and the existing surface.
- Run the universal testing machine (UTM) in direct tension mode at 4°C and a 0.5 mm/min loading rate, as shown in Figure 16.
- Calculate the bond energy at the surface.

**Figure 16. Testing for bond surface energy in an asphalt mixture performance tester (AMPT): control sample with a normal bonding material (left) and sample containing VRAM layer (right)**

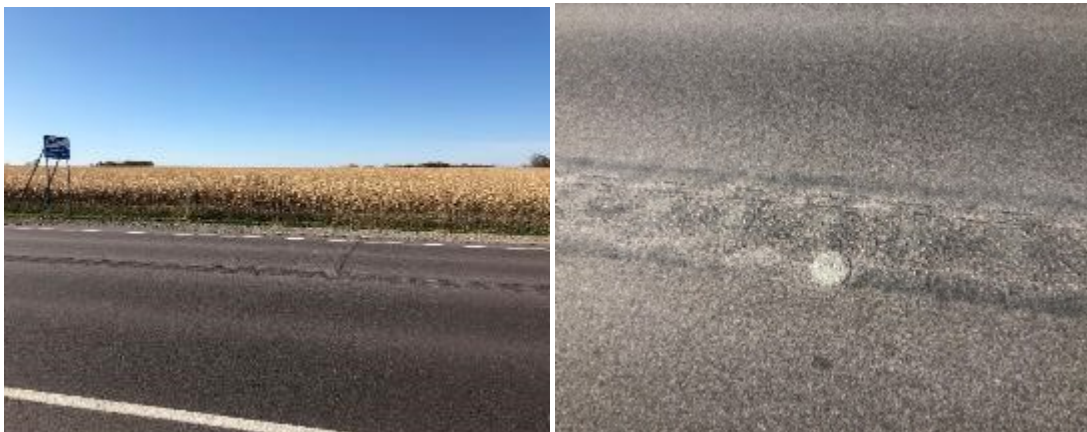
A field performance survey of TH 22 just north of Beauford, Minnesota, was carried out on October 25, 2019, one year after construction was finished. The pavement section made with J-Band did not show any noticeable distresses at the longitudinal joint, as shown in Figure 24.

**Figure 24. VRAM section on TH 22 between the cemetery near 179th Street and 169th Street**

In both the control and VRAM pavement sections, minor amounts of raveling were observed in the middle of the mat between the wheel paths. Because there were no noticeable distresses (primarily longitudinal joint cracking) within 9 in. of each side of the longitudinal joint, it was not possible to make correlations between field performance and laboratory performance after only one year. More time is needed to differentiate the J-Band sections from the control sections in terms of field performance.

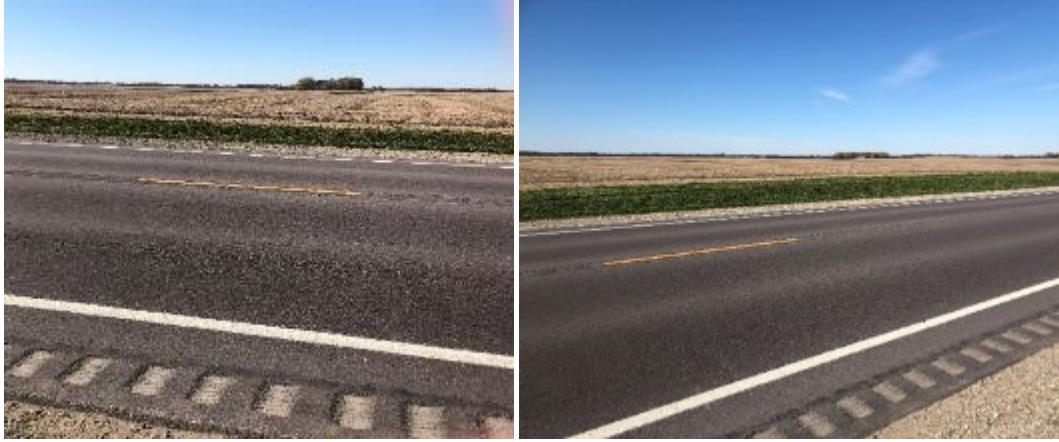
The control section (without VRAM) on TH 22 also did not show any noticeable distresses at the longitudinal joint, as shown in Figure 25.

**Figure 25. Control section on TH 22 north of the cemetery near 179th Street**

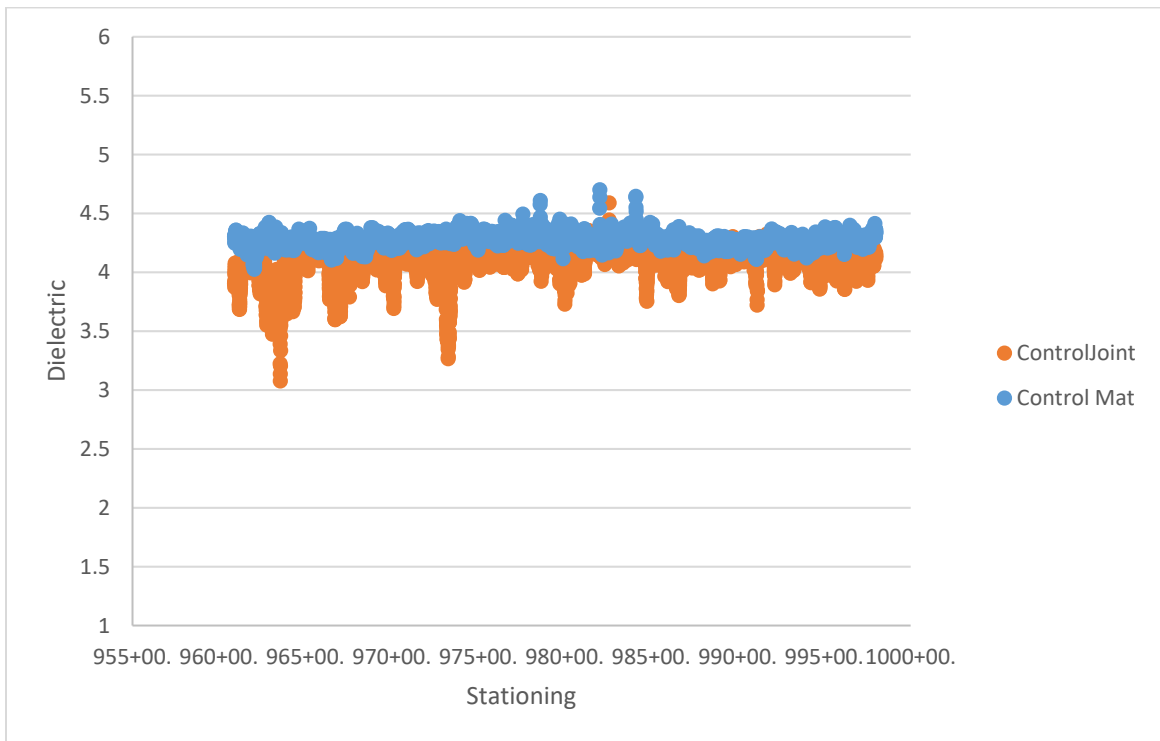
From observing the dielectric constant data shown in Figures 26, 27, and 28, it can be seen that the pavement mats have higher dielectric constant values than the joints.

Figure 27. Dielectric constant data for the control pavement section

Past literature shows that lower dielectric constant values indicate higher air void contents/lower densities in the pavement. Thus, the values collected through GPR correlate well to what has been shown in past literature (Hoegh and Dai 2017, Hoegh et al. 2018, Hoegh et al. 2015, Hoegh et al. 2019, Hoegh et al. 2020). However, it can be inferred based on the results that VRAM has a positive impact in terms of increasing the pavement density/lowering the percent air voids because the dielectric constant values obtained at the joint are much closer to the values obtained at the mat in the VRAM section than they are in the control section.

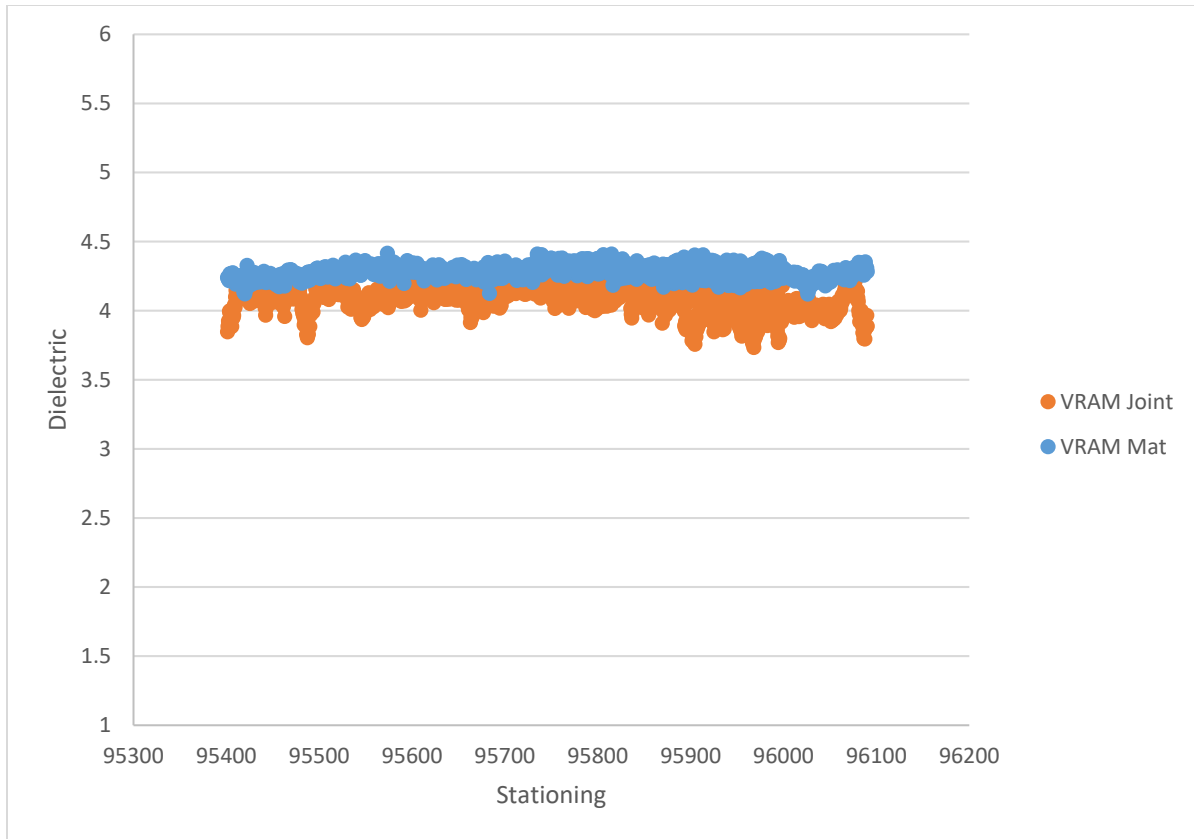
**Figure 28. Dielectric constant data for the VRAM pavement section**

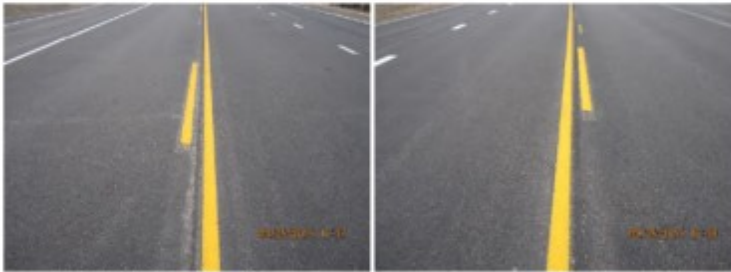
Figure 1 J-Band US169, Good condition.

- Centerline rumbles on much of J-Band.
- Generally did not notice anything out of ordinary. several segments with longitudinal joint showing lost material. Material loss limited to top layer of rock: 1 in. wide and 0.5 in. deep. Otherwise in good condition. Good condition at south end of application (FIGURE 1)
- Some locations showed slight material loss in the longitudinal joint near middle of application (FIGURE 2)
- Longitudinal Joint Adhesive was clearly visible in those areas (FIGURE 3)

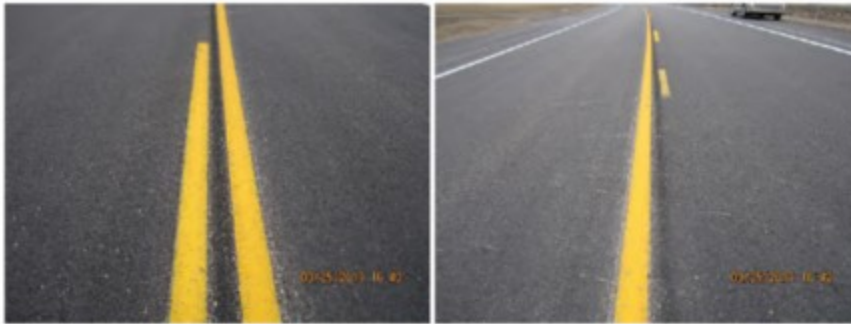
Figure 2 J-Band US 169. Some material loss along joint.

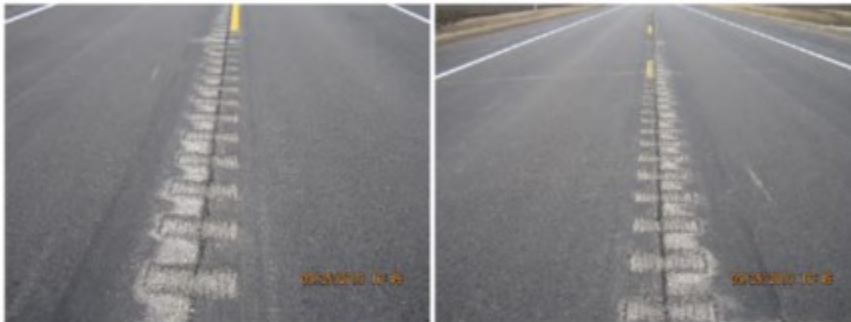
Figure 3 Longitudinal Joint Adhesive US 169. Good condition.

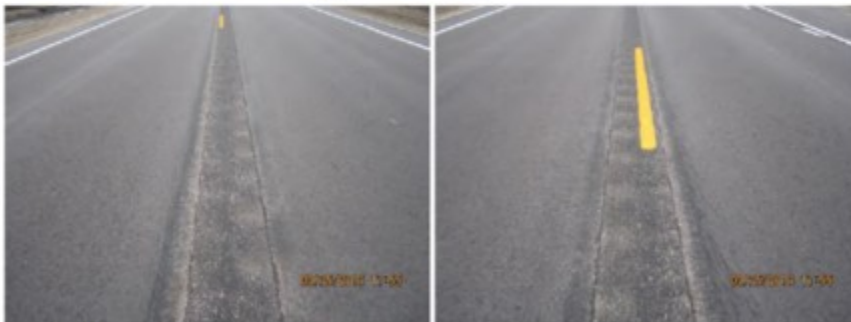
Figure 4 TH 22 J-Band. Good condition.

- Centerline rumbles on much of J-Band.
- Generally did not notice anything out of ordinary
  - Good condition at south end of application (FIGURE 4)
  - Good condition at north end of application (FIGURE 5)
  - Control north of applicaton was in good condition.

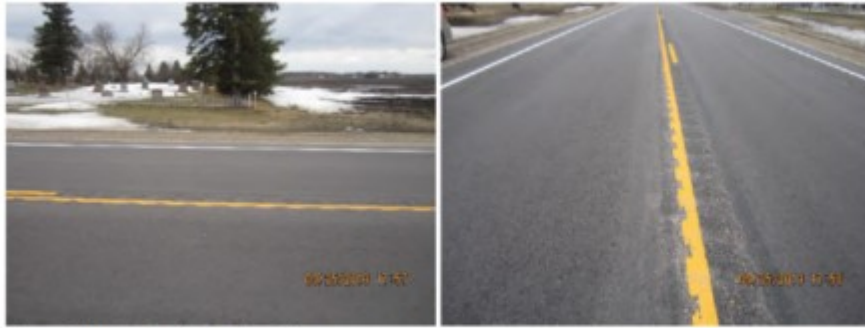
Figure 5 TH 22 J-Band. Good condition.
